# STATE FIRE MARSHAL'S OFFICE

## Firefighter Fatality Investigation

**Investigation Number 05-218-02**

**Captain Grady Burke**

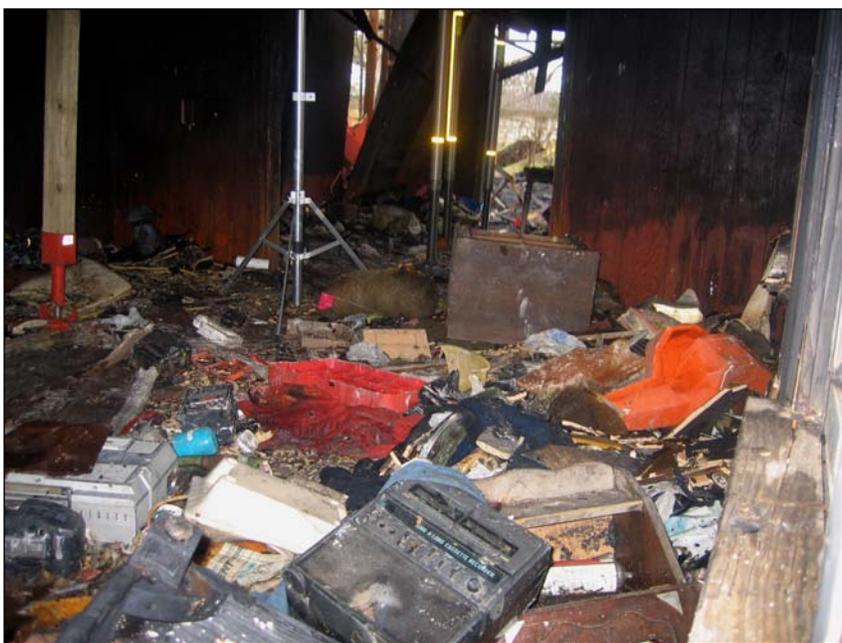
Interior of 8510 Brandon (post fire)

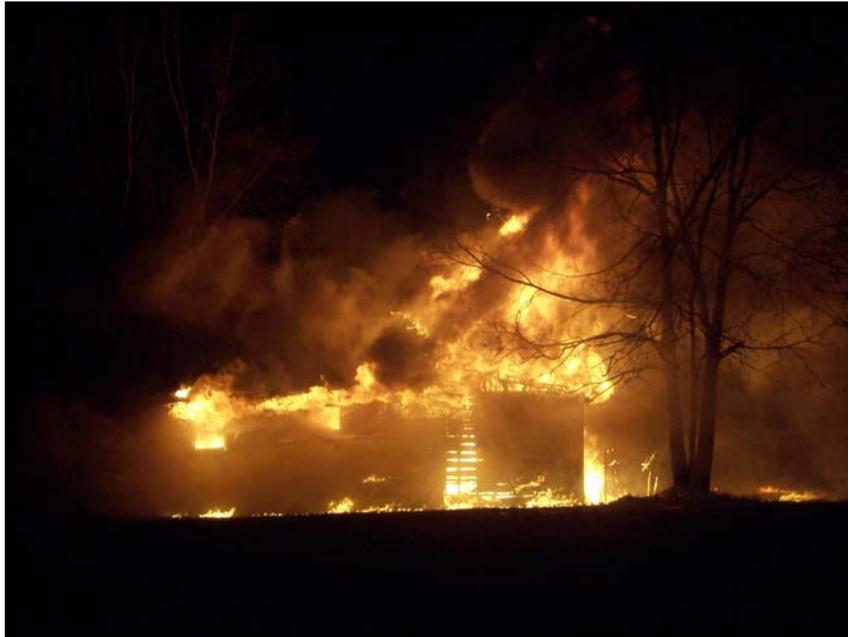
**North side of 8510 Brandon shortly after firefighters entered.  
(Houston Fire Department Photo)**

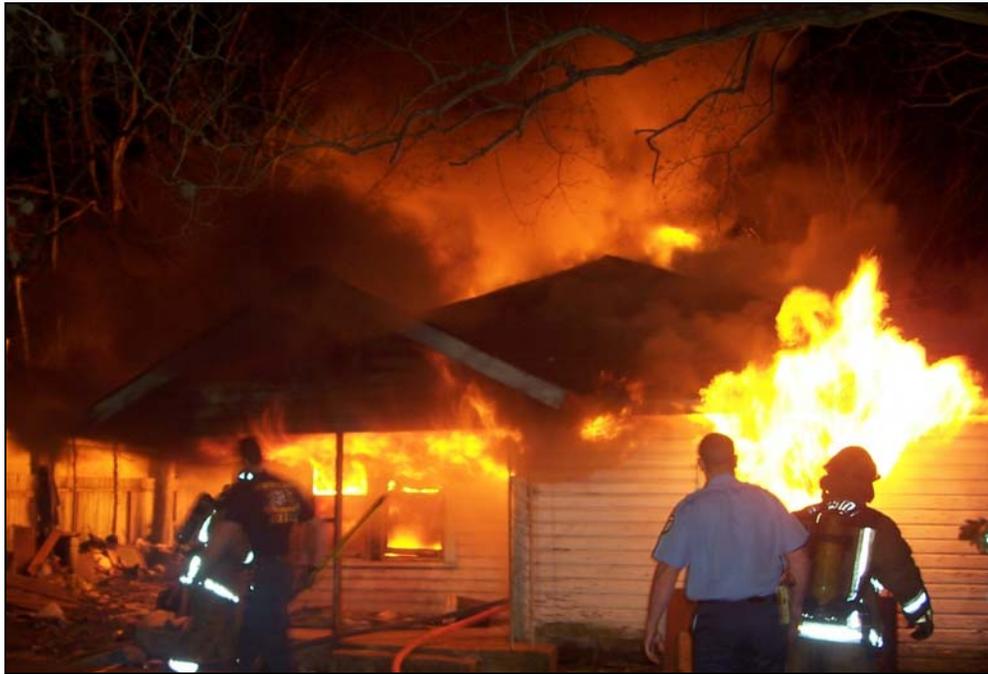
**Front (East side) of 8510 Brandon at the time the roof collapse forced smoke and burning gases throughout the building. E46 and L46 crews are inside the building at this time. (Houston Fire Department Photo)**

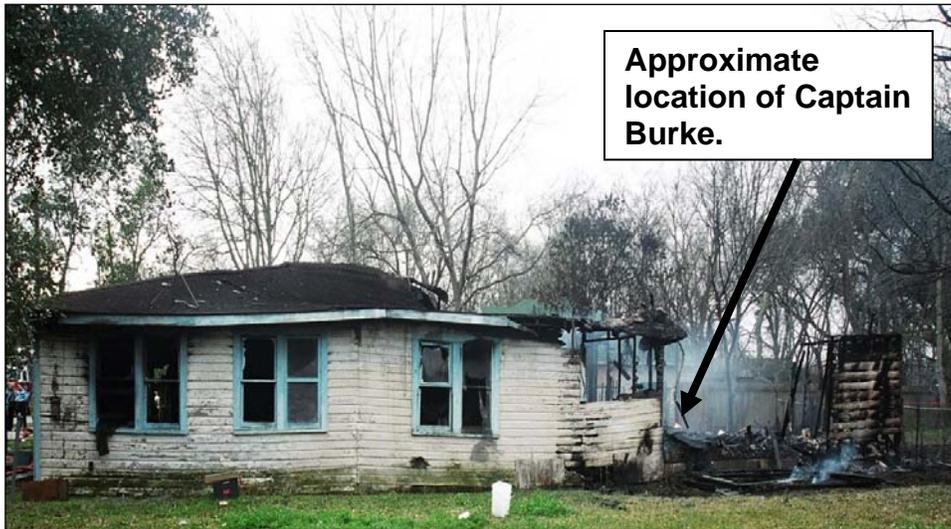
**North side of 8510 Brandon (post-fire) (Houston Fire Department Photo)**

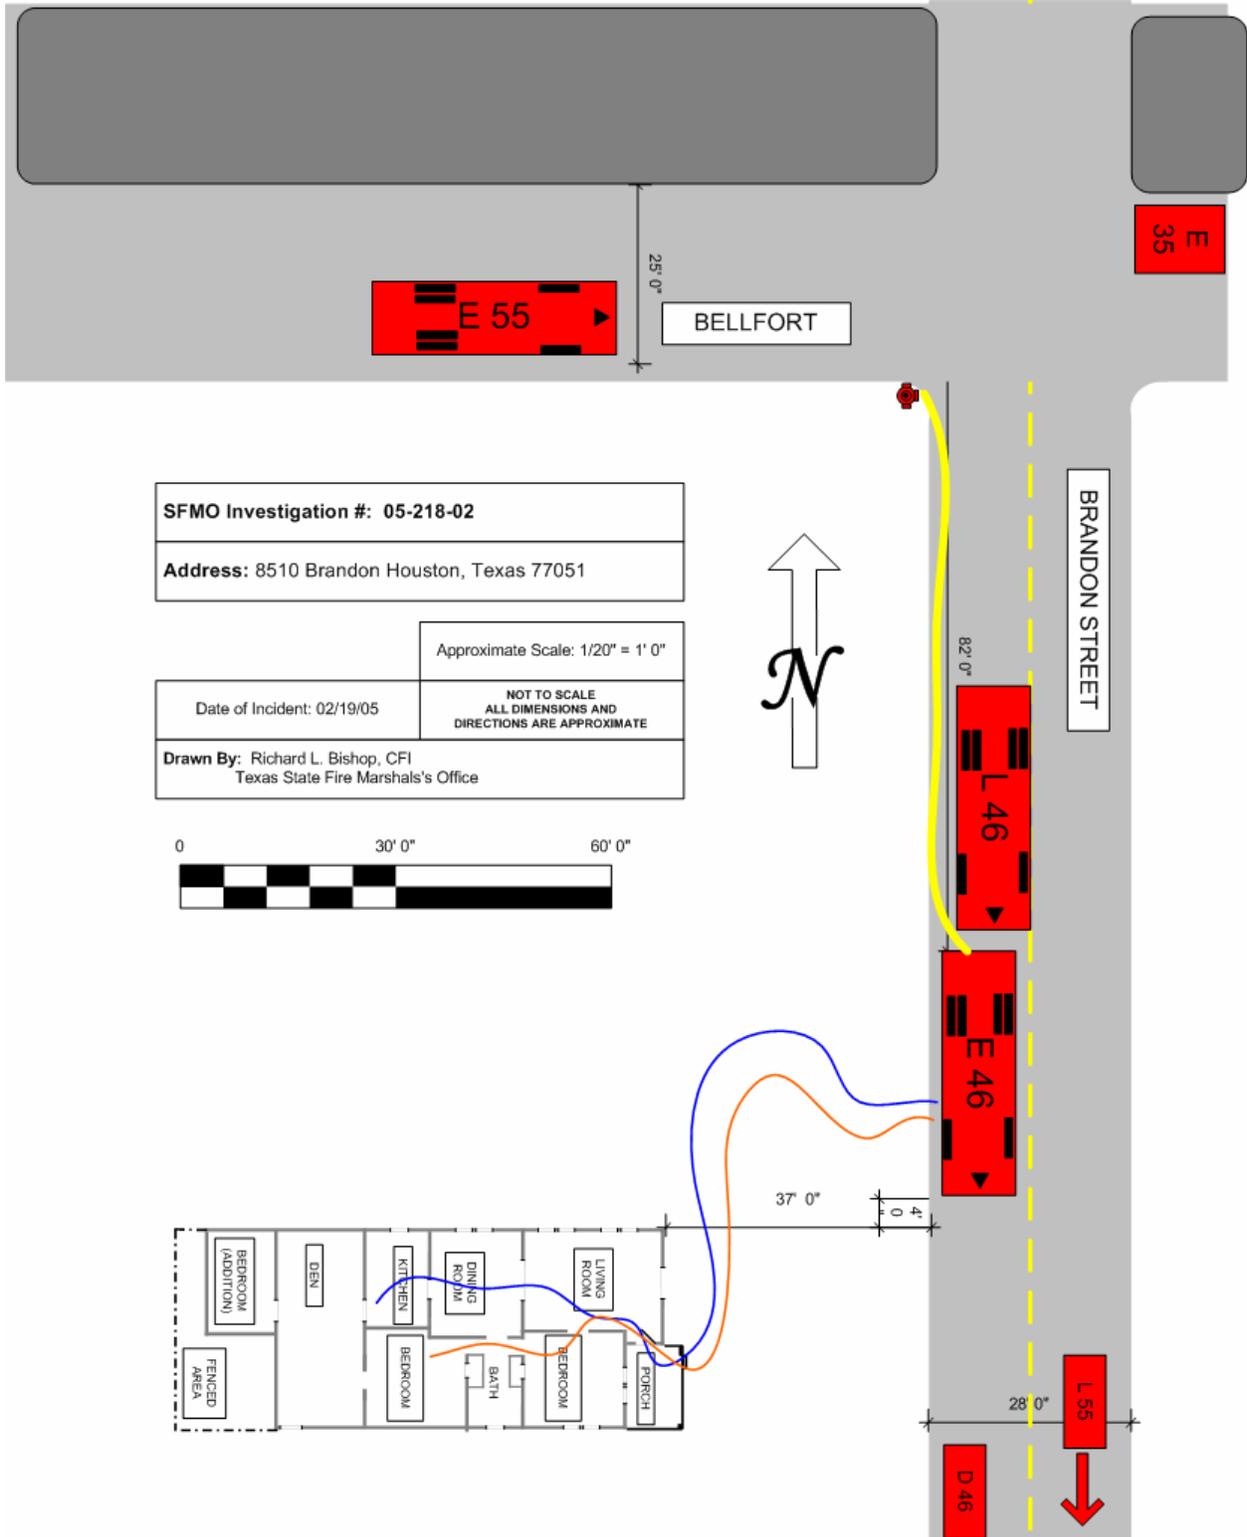
<b>SFMO Investigation #: 05-218-02</b>	
<b>Address: 8510 Brandon Houston, Texas 77051</b>	
Approximate Scale: 1/8"=1' 0"	
Date of Incident: 02/19/05	NOT TO SCALE ALL DIMENSIONS AND DIRECTIONS ARE APPROXIMATE
Drawn By: Richard L. Bishop, CFI Texas State Fire Marshals's Office

Captain Burke was found lying prone near the passageway from the kitchen area to the den area. Most of his protective equipment had burned away. Firefighters who found him attempted to remove him from the building but were stopped near the rear porch area when it became obvious that Captain Burke was deceased. (See diagrams at end of report)
