STATE FIRE MARSHAL'S OFFICE

Firefighter Fatality Investigation

Investigation Number 05-307-04

Firefighter Christopher Brian Hunton

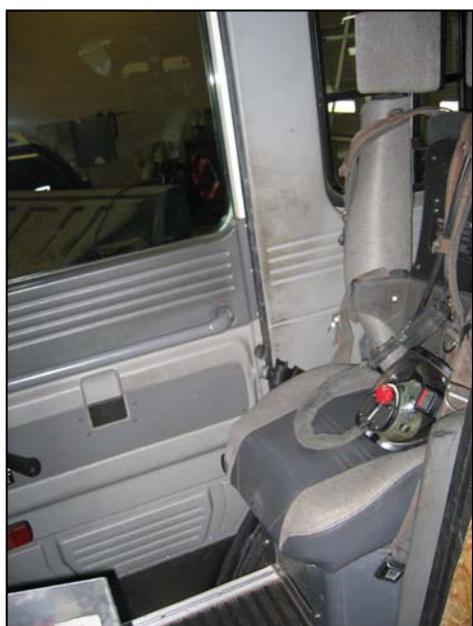
The lap belt on the seat in which firefighter Hunton was riding was unbuckled and retracted. The safety belt appeared to be in functional condition with no binding or other impediments to use. The safety belt on the right rear-facing crew seat was buckled around the seat cushion in a manner that indicated it was not customarily worn. There are warning signs in several location in the cab area emphasizing the need to be seated and to wear safety belts when the vehicle is in motion.

(Left) Left rear crew seat and (above) warning label in crew compartment. (Below) Right rear seat.

Recommendation: Firefighters should follow departmental policy by donning all protective equipment and fastening their safety belts prior to moving the apparatus.

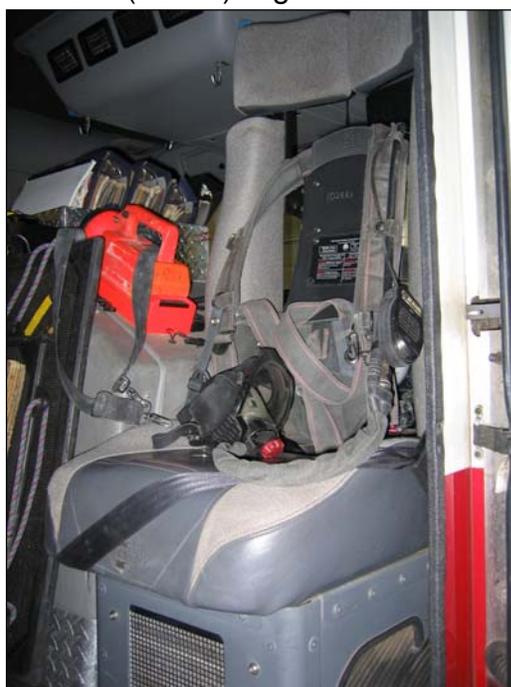
Ladder 1 is equipped with a safety belt monitoring system with an audible and visual alarm to indicate if a safety belt is not fastened in an occupied crew seat. The monitoring system was not functioning and the sensor wiring on the right rear jump seat was disconnected. No further examination of the system and seat sensors was conducted by SFMO, pending an engineering evaluation of the vehicle and left rear door latching mechanism.

Recommendation: Existing safety monitoring systems on apparatus, while not required, should be maintained in operable condition to enhance personnel safety and to avoid a false perception of safety. All fire apparatus should be inspected at least

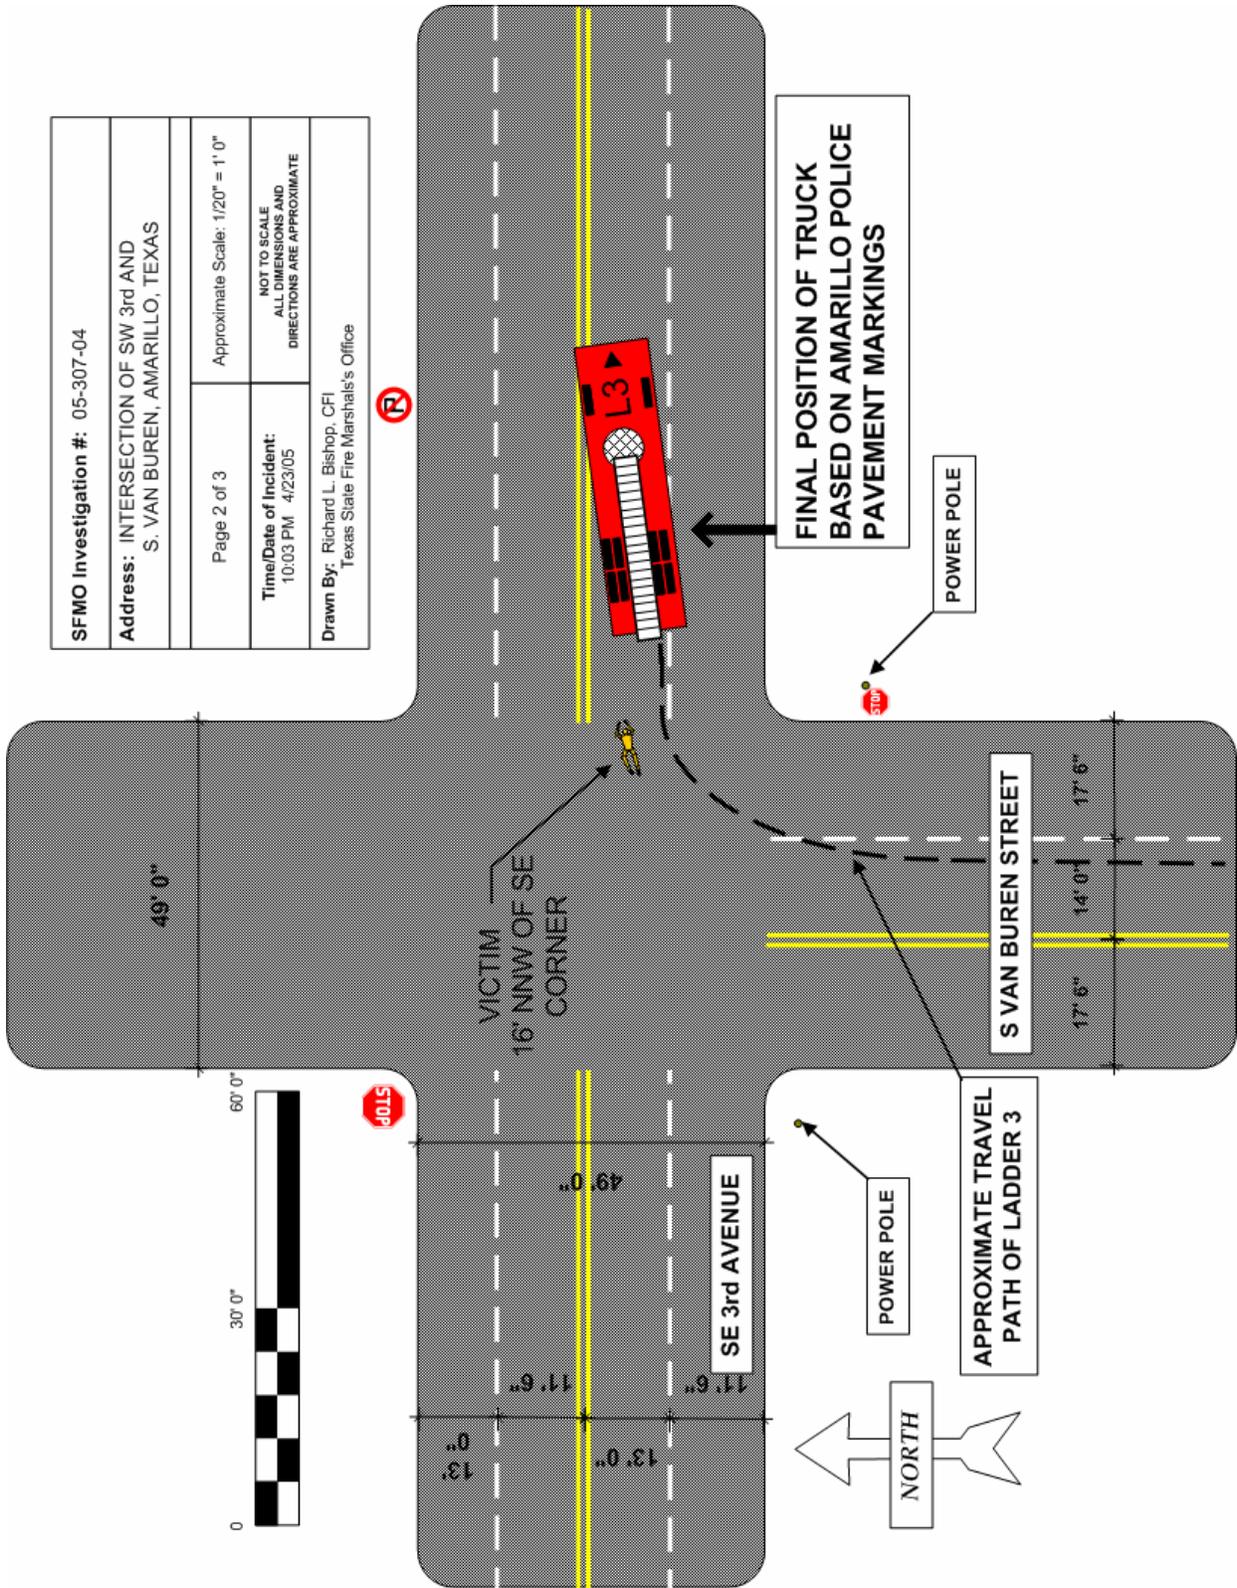
The Amarillo Police Department did not make any measurements at the incident scene other than those used to construct a diagram showing the location of firefighter Hunton in the intersection of 3rd and Van Buren. The Police Department did mark the location of the tires of Ladder 1 after it stopped, and these markings, combined with the police report diagram, were used to construct the SFMO diagram of the scene on April 28, 2005. (Diagram located at the end of this report)
