State Fire Marshal's Alert

February 22, 2006

University Campus Liquid Nitrogen Cylinder Explosion

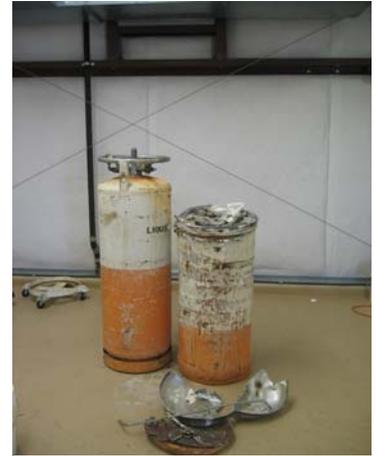
Figure 1 -Effect of Explosion on Dewar Cylinder Compared to unaffected cylinder

The State Fire Marshal's Office, in cooperation with the university's environmental health & safety office, conducted an investigation that included an assessment of the building damage and reconstruction of the events leading to the explosion. The resulting examination revealed catastrophic failure of the cylinder. The failure permitted rapid expansion of the nitrogen gas, blowing out the bottom of the tank and propelling the cylinder upwards.

The examination revealed that the cylinder's pressure release valve and rupture disc had been replaced by two brass plugs. Without these two features in place, the cylinder's rupture-prevention function became compromised. During the investigation, lab students related that the bottom portion of the cylinder had been frosting for approximately twelve to eighteen months, suggesting to them that the cylinder was "leaking". It is speculated that

the tank was relieving normal excessive pressure through an old leaking gasket on the top of the tank (the actual pressure-relief function had been plugged). Approximately twelve hours prior to the explosion, one of the students replaced the leaking gasket and refilled the cylinder. As the old gasket that helped relieve internal pressure had been replaced, the now full cylinder was completely sealed. The cylinder ruptured when its internal pressure rose above 1,000 psi.

The catastrophic failure of the nitrogen cylinder was a direct result of the removal and subsequent plugging of the internal tank pressure relief devices. The cylinder was modified by inexperienced and unidentified person(s) resulting in the eventual failure of the cylinder. It could not be determined when the modifications took place.

- Repair, replace or remove from service leaking, damaged, or corroded compressed gas cylinders or systems.
- Implement and sustain a preventative maintenance program for all compressed gas cylinders and systems. A preventative maintenance program shall include periodic inspection of all cryogenic fluid storage systems and replacement of pressure relief valves every five years, ensuring the valve is set as required by the tank design. A record of the inspection should be prepared and provided to the user or the authority having jurisdiction upon request.

- Ensure that an individual trained in tank usage be in attendance at all times cryogenic fluid is transferred from one container to another.
- All service, repair, modification, or removal of valves, pressure-relief devices, or other container appurtenances shall be performed in accordance with National Fire Protection Association (NFPA) Standard 55 and the Compressed Gas Association (CGA) guidelines (<http://www.cganet.com/publication.aspx>).

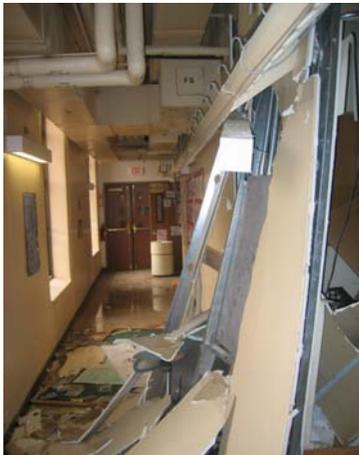
Figure 2 - Hallway Outside Laboratory Showing Explosion Damage

At approximately 3:00 a.m. on Thursday, January 12, 2006, an explosion occurred in a state university chemistry building laboratory, causing substantial building damage. The explosion resulted from a rupture in a liquid nitrogen (Dewar) cylinder. The cylinder was originally constructed and tested in December 1980.

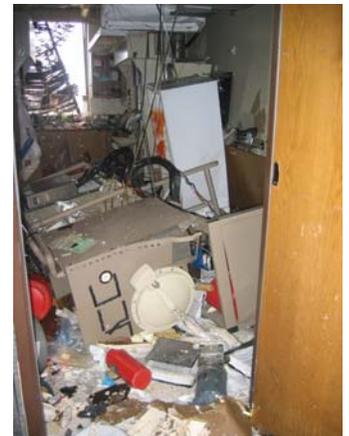
Figure 3 - Inside the Laboratory after Explosion
