# **Firefighter Fatality Investigation**

**Houston Fire Department**

Investigation FFF FY 13-08

Houston, Texas  
May 31, 2013

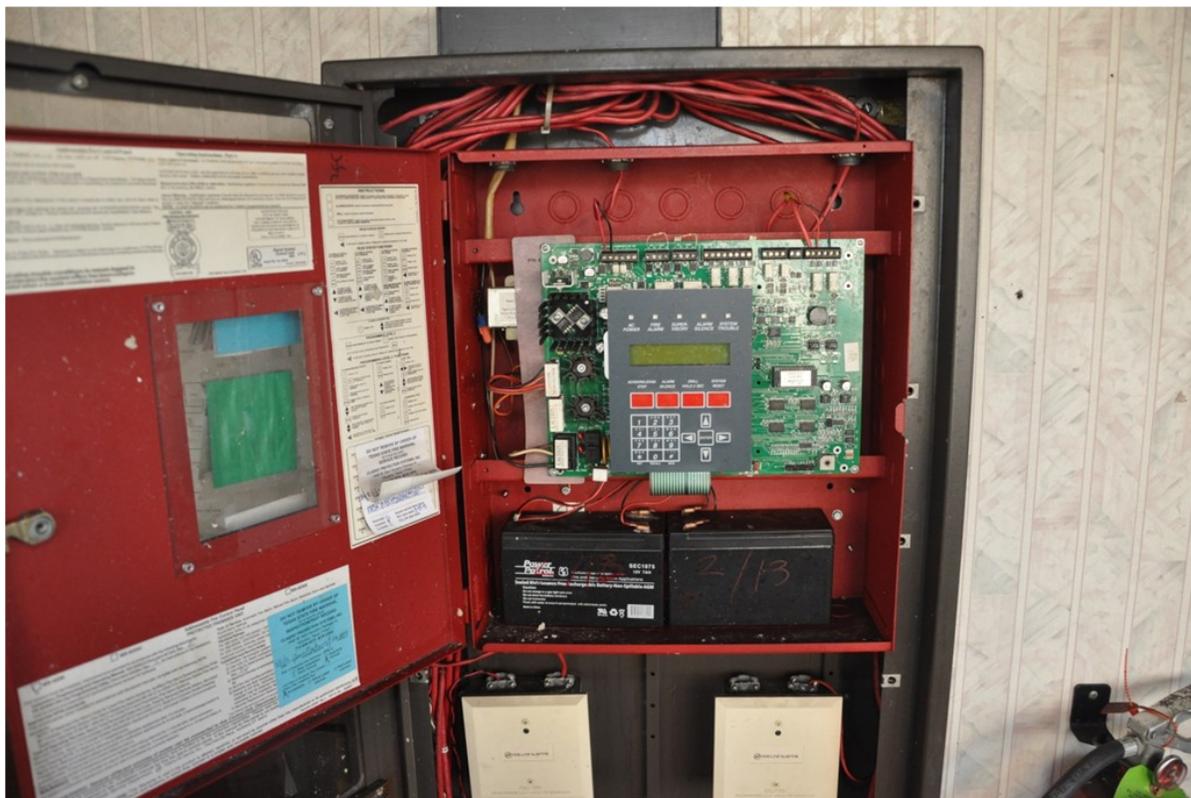
*Fire Alarm Panel*

The building was not equipped with a fire sprinkler system or an automatic fire alarm system, and was compliant under the code of record for these features according to the Houston Fire Inspection Division. The complex was equipped with a manually operated fire alarm system with manual pull stations and audio alarm/visual alarm devices throughout the complex. The system control panel was located in the offices inside the main building.

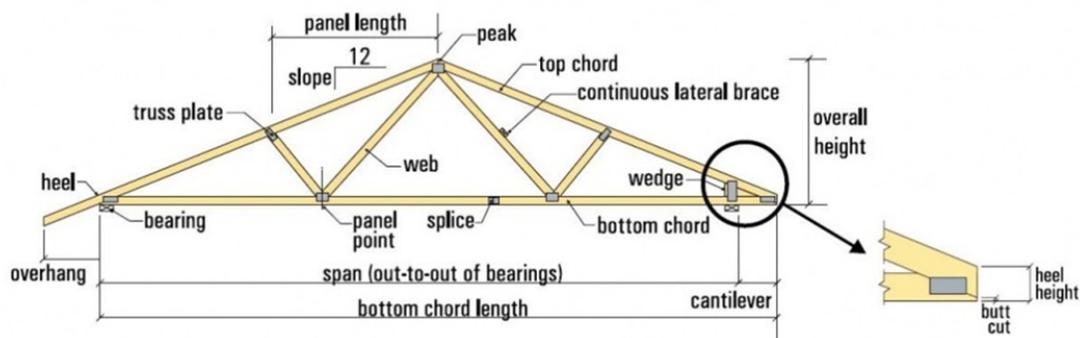
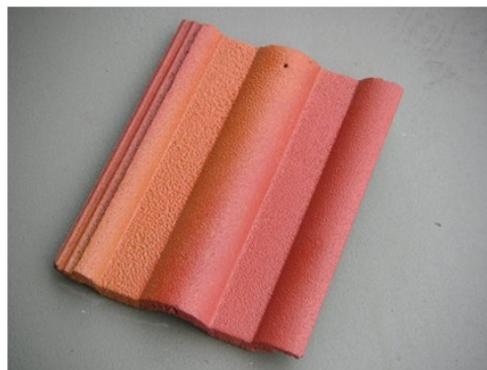
The evaluation of the roof system by the engineering firm concluded that the roof structure dead load was approximately 66.5 percent of the total dead load capacity of the roof structure. The roof failure was determined to be the result of fire exposure and not a failure of the construction method or weight of the roof.

The State Fire Marshal's Office investigation team determined that the construction method and the added weight of the cement tiles may have contributed to a decrease in the time to failure under the conditions of an attic fire.

Identifying modifications to roof structures or environmentally damaged structures of target hazards should be included as a primary segment of pre-incident tactical planning. The addition of the concrete tile roof materials, overlaid onto the existing asphalt roof, added several pounds per square foot to the roof's weight. The attic fire attacked the roof's structural members, weakening the roof structure, and the weight of the roof shortened the time from the incipient stages of the fire to the time of collapse.

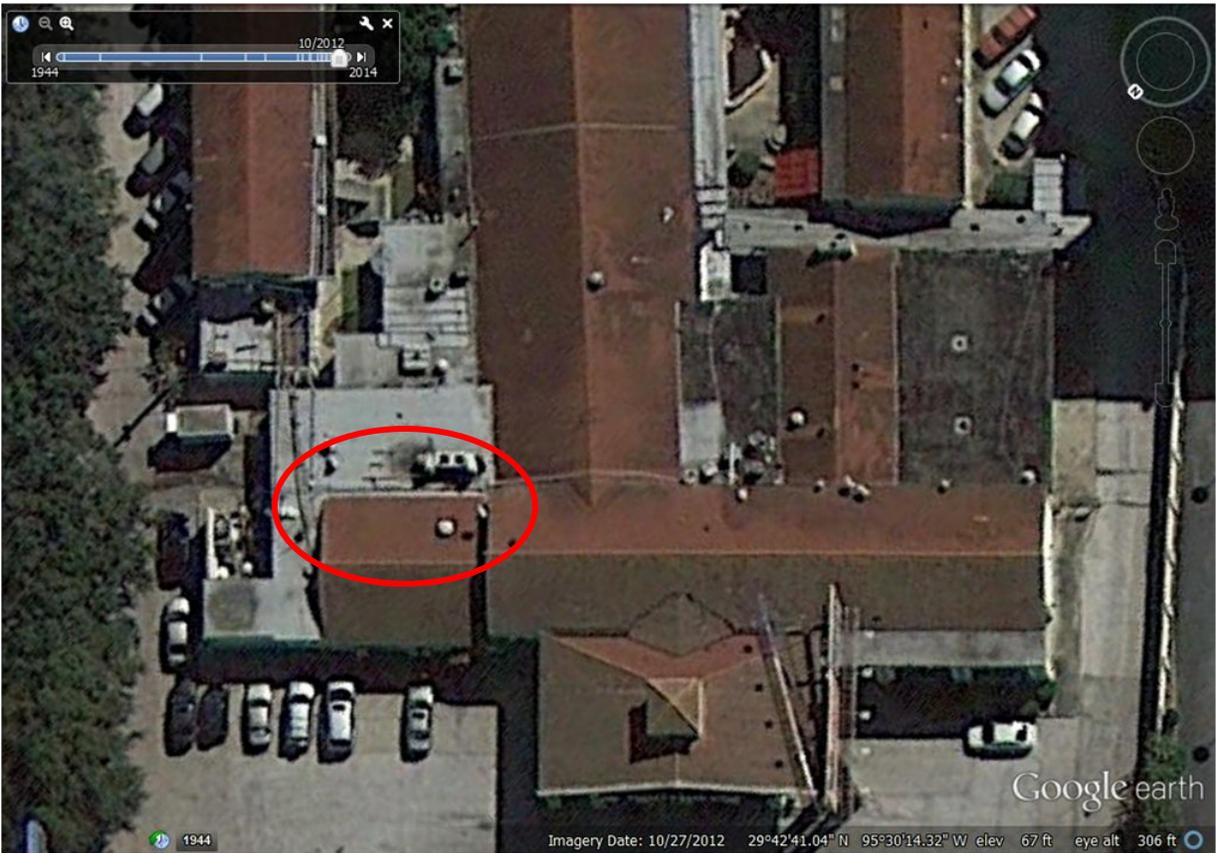
Based upon the information available and after conducting a systematic fire scene examination, inspecting the physical evidence, viewing fire scene video, viewing photographs, arc mapping, considering firefighter statements, considering witness observations, conducting extensive testing, and employing the scientific method by means of formulating and discarding hypotheses, it is the opinion of investigators that the area of origin could not be exactly identified. The area of origin encompasses the east entry area to the west end of the kitchen area including a utility room, a walk-in cooler, and the concealed/attic space above.

The cause of the fire is unknown. Numerous hypotheses were ruled out. The incident classification is ***UNDETERMINED***.

*Approximate area of origin*

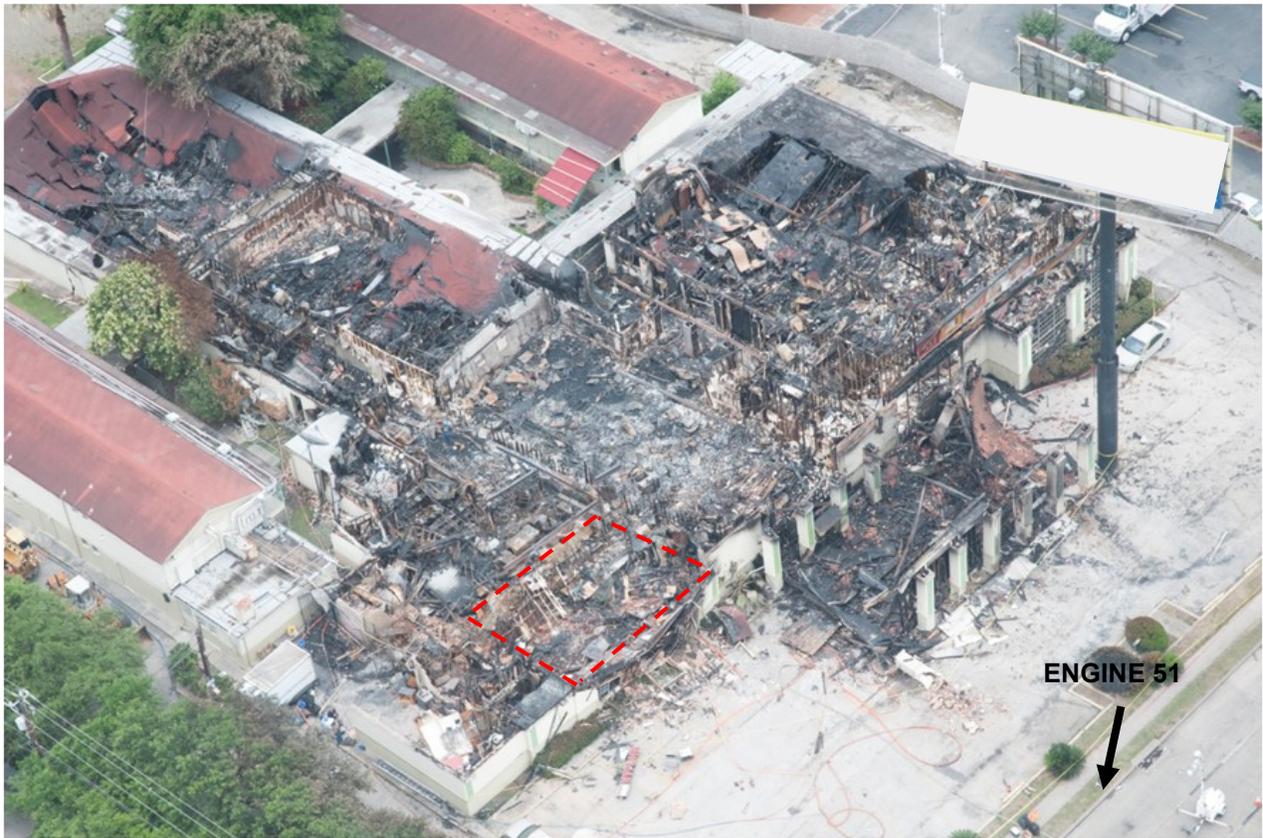
Shortly after the fire was seen venting through the roof the E60 captain stated they saw the roof collapse. E60 tried repeatedly to engage the radio but continuously got "bonked." Because of the inability to engage the radio, E60 physically went to Command to advise them of the situation.

*Banquet room area of roof collapse*

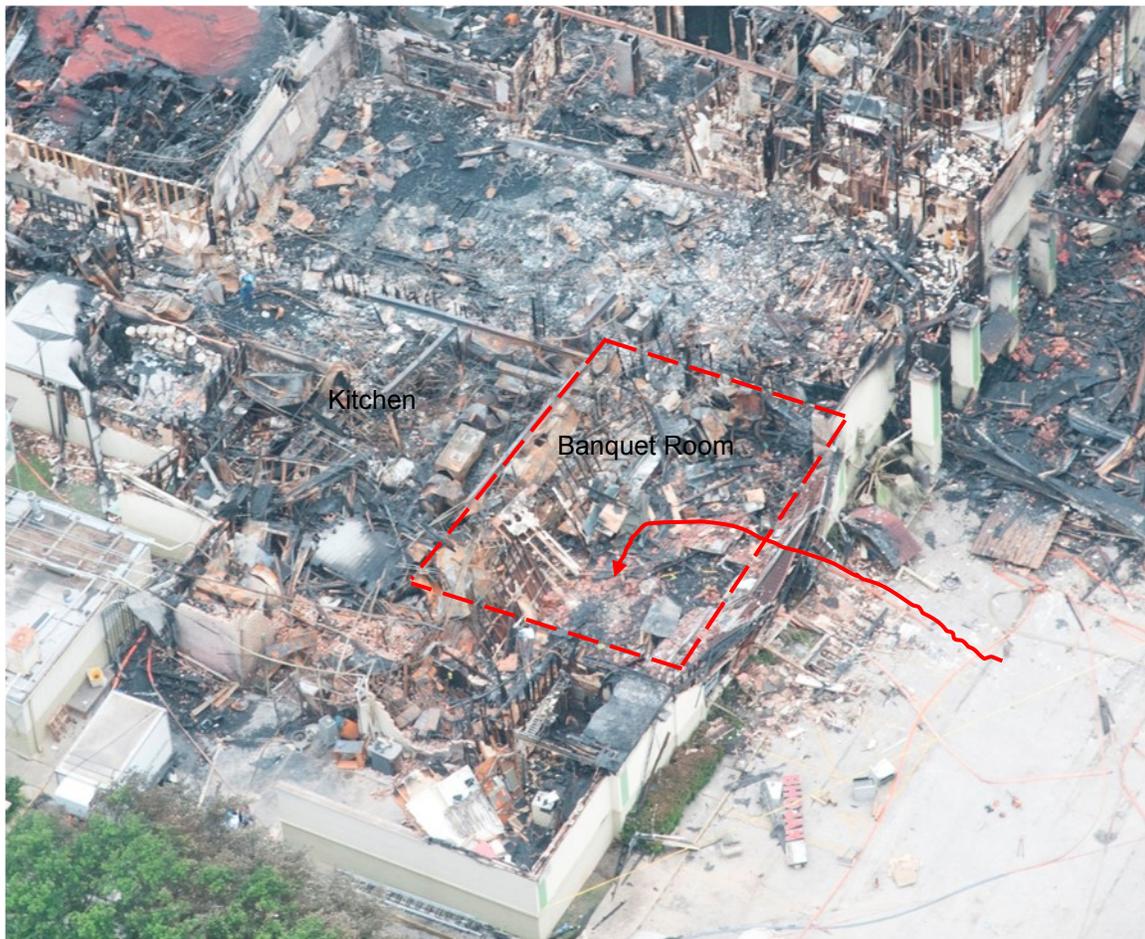
*Approximate direction of E51 hoseline*

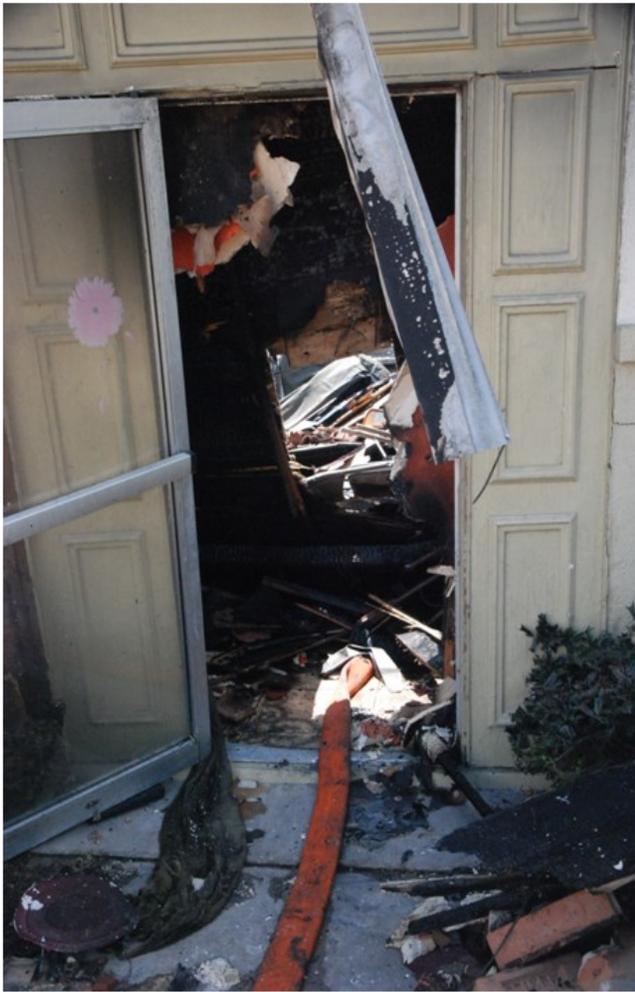
*View of the hoseline through the entry door and the hole cut in the roof*
