STATE FIRE MARSHAL'S OFFICE

Line of Duty Death Investigation

Investigation Number 02-524-08

Firefighter Travis Wiens

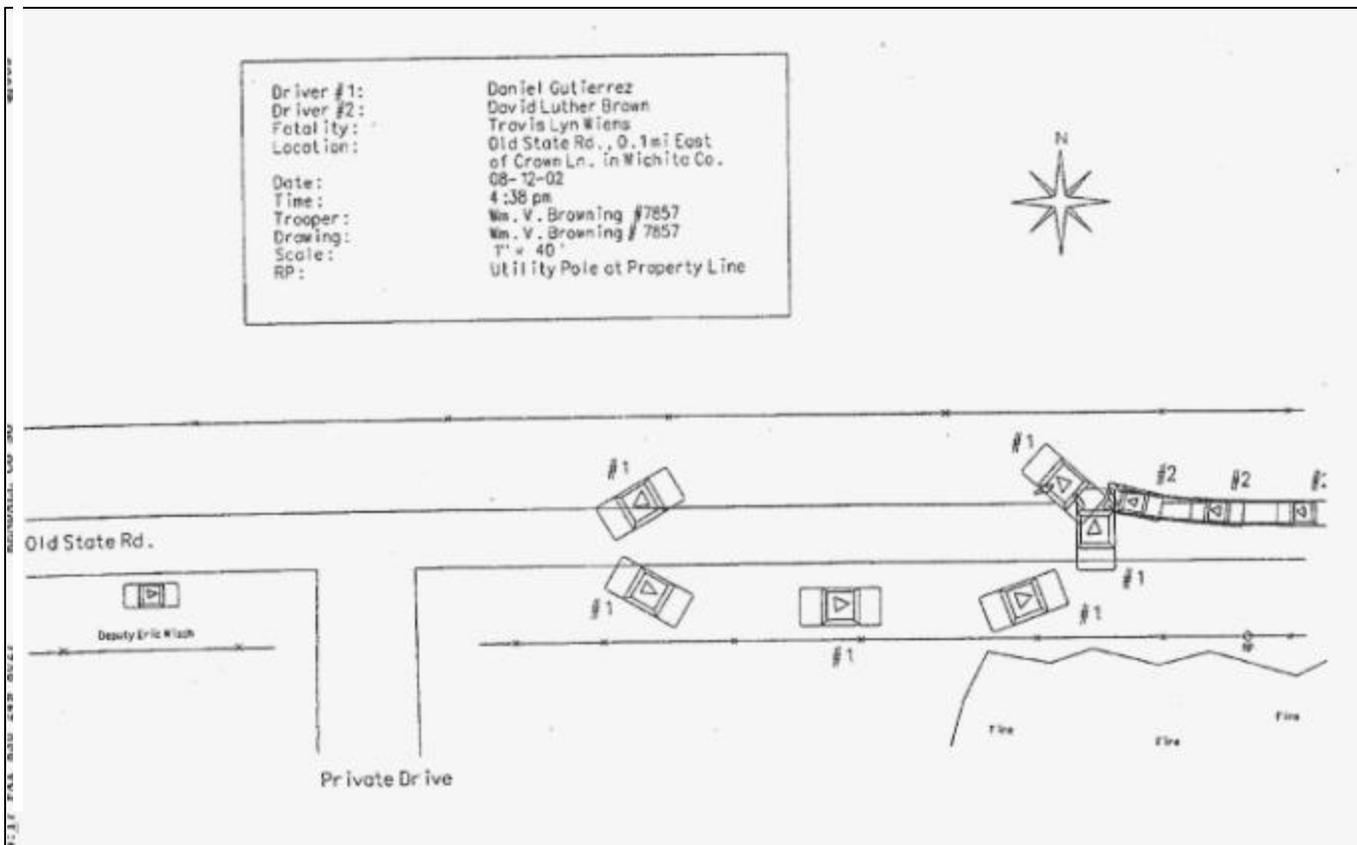
DPS Diagram-NOT TO SCALE

The speed limit on Old State Road is 55 mph. A ¾ ton pickup truck driven by David L. Brown was westbound on Old State Road when it entered the cloud of smoke. Brown estimated visibility at 30 to 40 feet. Brown stated he had moved far to the right to give room for any eastbound vehicles that were over the center of the unmarked blacktop roadway. As Brown proceeded through the cloud of smoke at 30-40 mph (Brown's estimate) he encountered the fire truck blocking the roadway. The driver applied the brakes, but was unable to stop and skidded 56 feet into the fire truck. Brown's truck collided with the right front tire and wheel of the fire truck.

The impact threw Engine 720 driver Gutierrez across the interior of the truck towards the passenger seat. Gutierrez was not wearing the safety belt installed in the truck. The impact also threw firefighter Wiens over the top of protective screen and bar on the front platform. Wiens lost his firefighters helmet during the fall from the platform and landed on the ground in front of the left front wheel of the fire truck. There was no safety strap or harness on the front bumper platform.

The truck, which was still in low gear with no one behind the wheel, lurched forward and rolled over Wiens' head and then continued to lurch forward approximately 24 feet from the point of impact. Wiens sustained massive crushing head injuries.

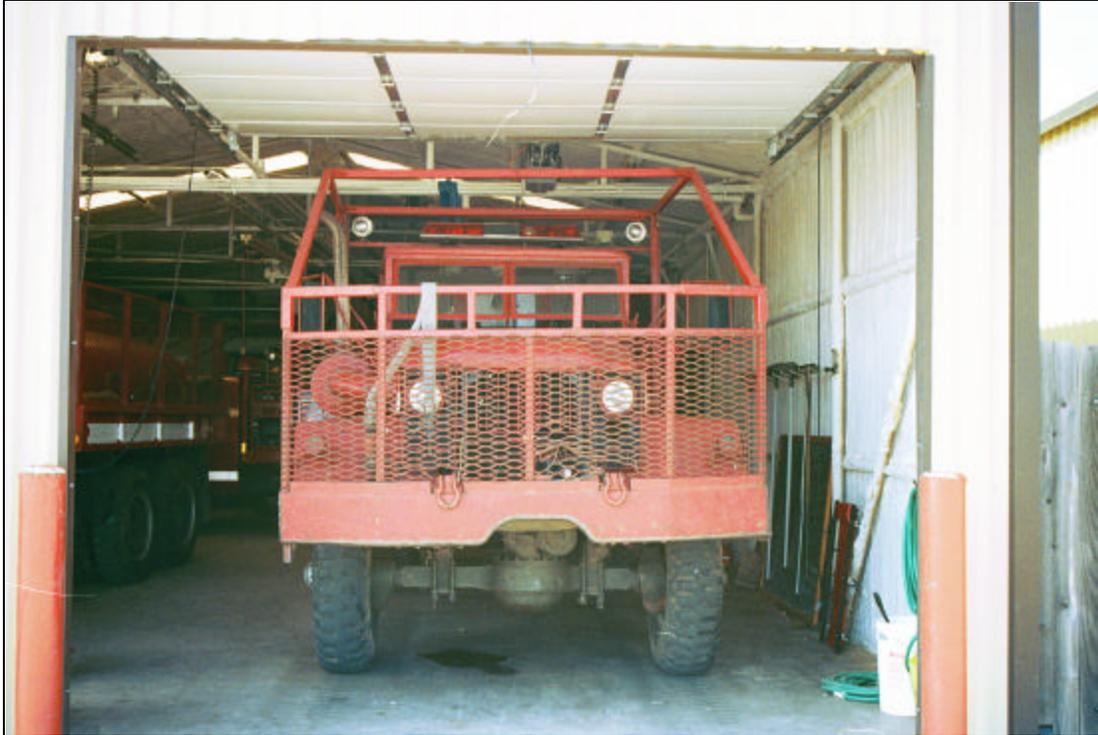
Wichita West Engine 720

The front bumper platform extended out approximately 36 inches. The bumper had an open frame that extended up to the cab and then down to the sides of the bumper. The lower front portion of the frame had mesh wire, which extended 39 inches from the top of the bumper to the cross member. The rest of the frame was completely open allowing uninhibited access from either side. There were no safety type harnesses or other safety devices for the front bumper platform.

The truck has been painted red. Four-inch-wide white reflective tape and reflective 911 emblems had been applied to both sides of the cargo bed. Red and white alternating reflective tape has been applied across the rear of the truck. The only warning lights on the vehicle are a full width red light bar mounted on top of the cab. The truck is also equipped with an electronic siren with the speaker mounted on the front bumper platform. Two high-mount white lights were installed for extra night visibility. There are no low-mounted or side-mounted warning lights.

There were no safety straps or harnesses installed on the front firefighting platform of the 5-ton brush truck.

- Personnel should not be allowed to ride on the front of wildfire firefighting apparatus at any time.

Accident prevention signs should be located on the vehicle at the rear step areas, and at front bumper extensions and cross walkways, if they exist. The signs should warn personnel that standing on these areas while the vehicle is in motion is prohibited.

- Firefighting should be limited to protected positions on the sides and rear of vehicles.

Firefighters in these positions should be protected by safety cages or belts that will prevent falls from vehicles. Rollover protection equipment should be considered for these types of vehicles.

Automatic nozzles may be installed on front bumpers to avoid placing firefighters at risk on an exposed position.
