# STATE FIRE MARSHAL'S OFFICE

## Firefighter Fatality Investigation

**Investigation Number 05-218-02**

**Captain Grady Burke**

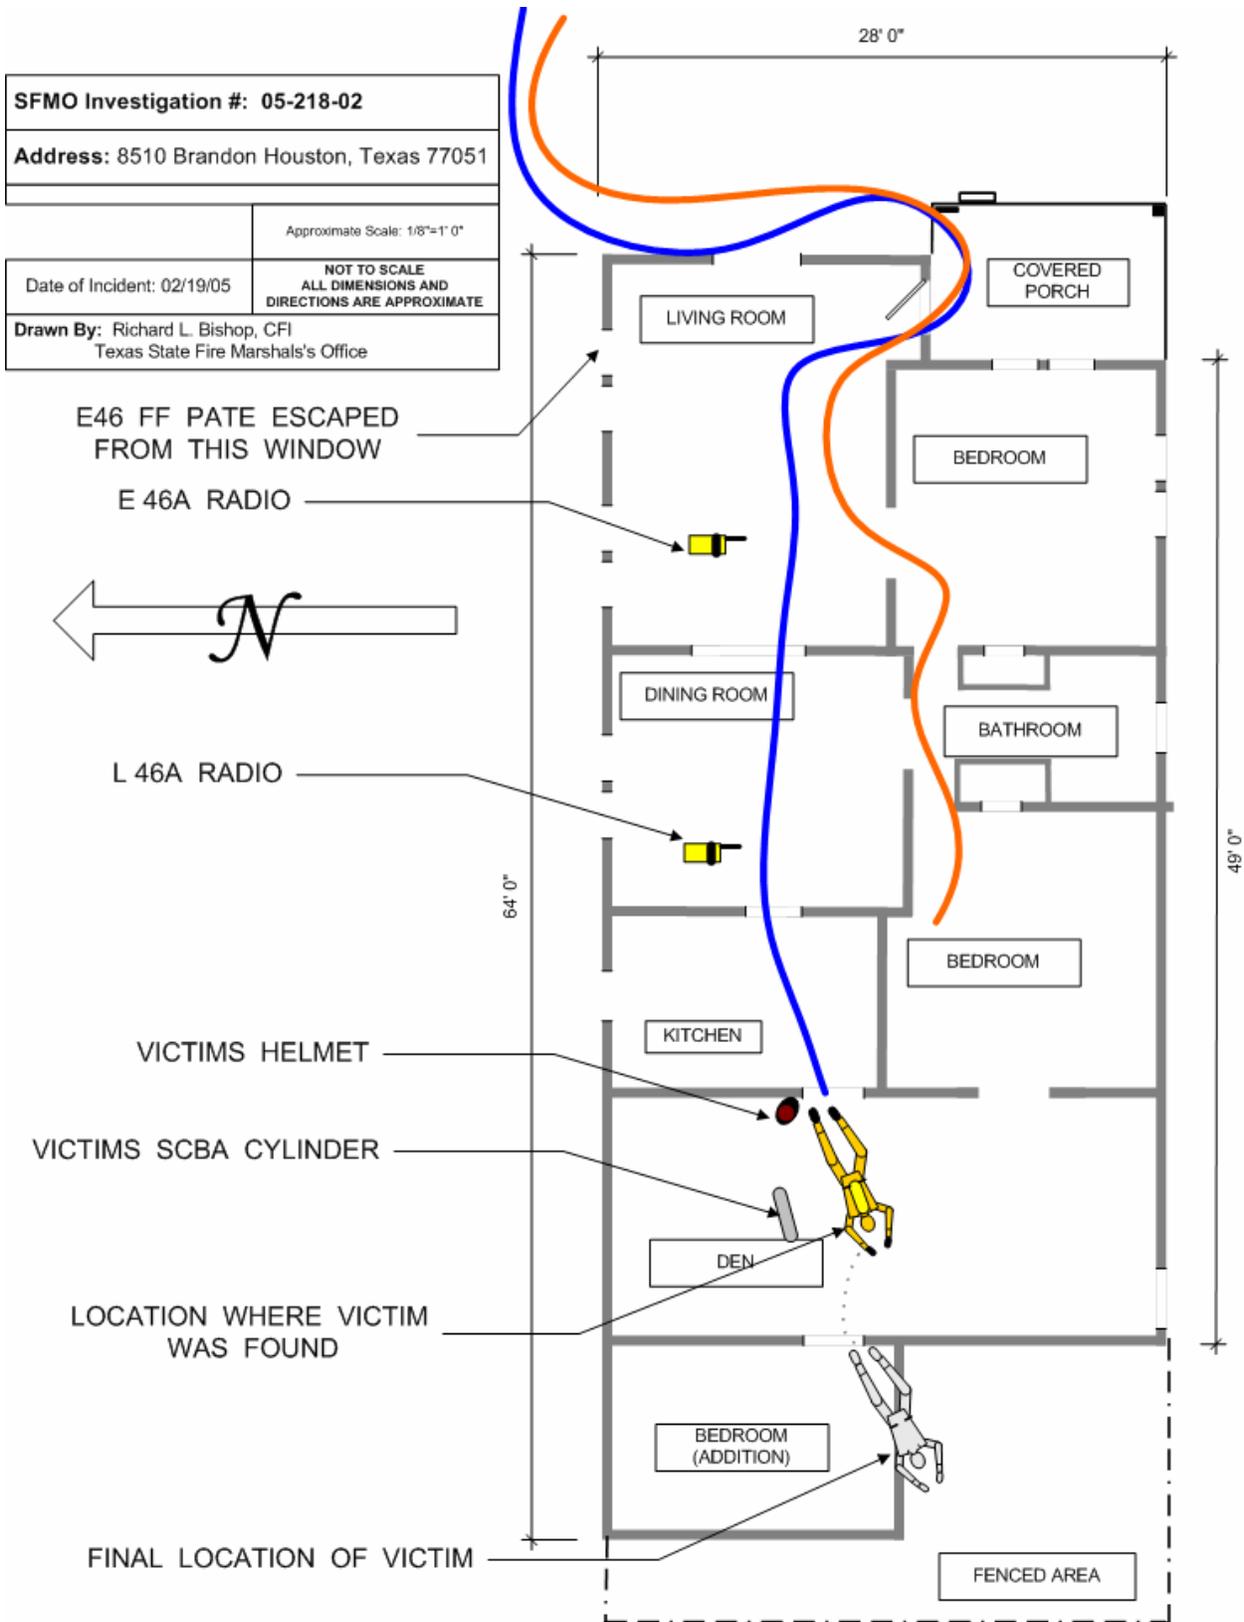
<b>SFMO Investigation #: 05-218-02</b>	
<b>Address: 8510 Brandon Houston, Texas 77051</b>	
Approximate Scale: 1/8"=1' 0"	
Date of Incident: 02/19/05	NOT TO SCALE ALL DIMENSIONS AND DIRECTIONS ARE APPROXIMATE
Drawn By: Richard L. Bishop, CFI Texas State Fire Marshals's Office
