AUSTIN'S NIGHT INSPECTION PROGRAM

BY DON SMITH

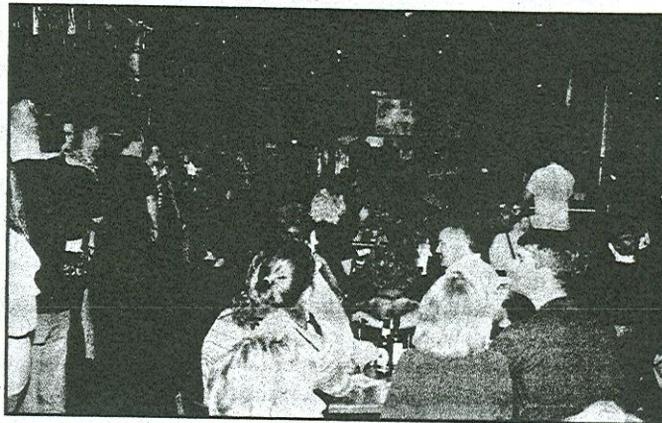
A well-maintained exit path in an Austin club. (Photo by Steve Titsworth.)
